An efficient method for monitoring the shunts in silicon solar cells during fabrication processes with infrared imaging*

Abstract: In order to monitor the fabrication process, an infrared imaging system was established to detect the shunted regions in crystalline silicon solar cells. The temperature of the shunted region was obviously higher than that of the non-shunted region when the cell was biased under direct voltage due to the Joule heat effect, and the shunted region could be detected by infrared imaging. The shunts caused by seven different reasons can be identified using metallurgical microscopy, scanning electron microscopy, and energy dispersive X-ray spectroscopy. Approaches for diminishing shunts are presented. The methods are beneficial for the optimization of the cell fabrication processes and the improvement of the cell performances.

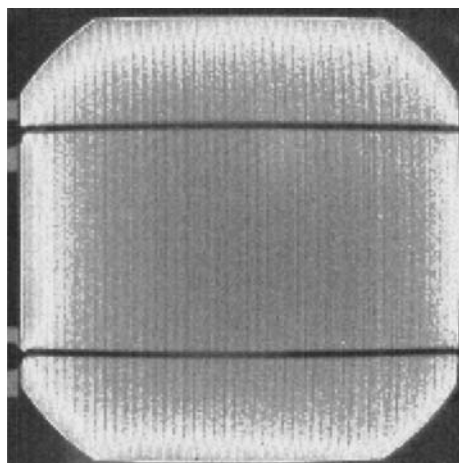
Fig. 2. Shunts caused by incomplete plasma etching.

contact, the heavily doped region on the periphery must be removed by plasma etching (PE). But if the PE parameters were not properly given, there would be residual emitter on the flank. Figure 2 shows the periphery shunted regions caused by incomplete PE, and this kind of shunts could be removed by prolonging the etching time or by increasing the PE power.

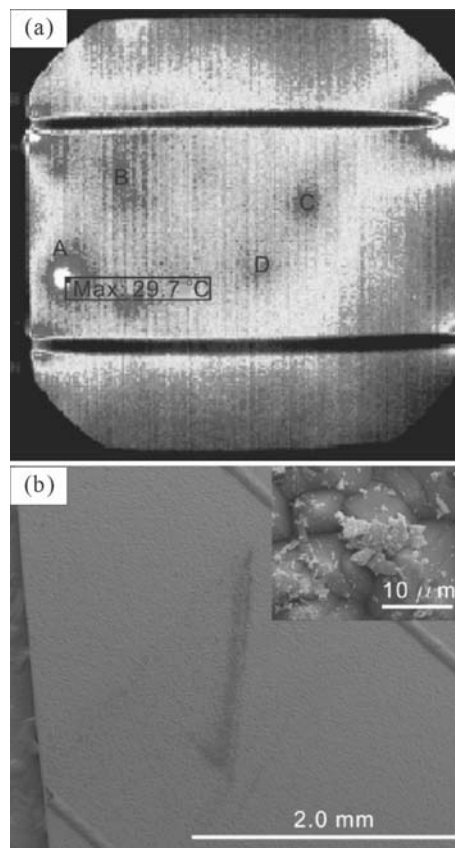
The photovoltaic cells needed to be stacked together for large scale production. But the inappropriate handling could cause scratches on the wafer surface and then cause the base layer to be exposed. Then the exposed p-type base could be connected directly to the front emitter probably through the absorbed dusts and metal particles, and a shunt was induced. Figure 3(b) shows the SEM image of the scratched region A on the front cell surface, and the upper inset clearly depicted the damaged pyramids. Figure 3(a) is the thermo-image of the whole cell on which other scratched regions B, C, and D were also displayed. Careful handling during the fabrication could decrease the scratch induced shunts and improve the cell performance.

Fig. 3. (a) Thermo-image of the scratched solar cell; (b) SEM images of the worst scratched region A.

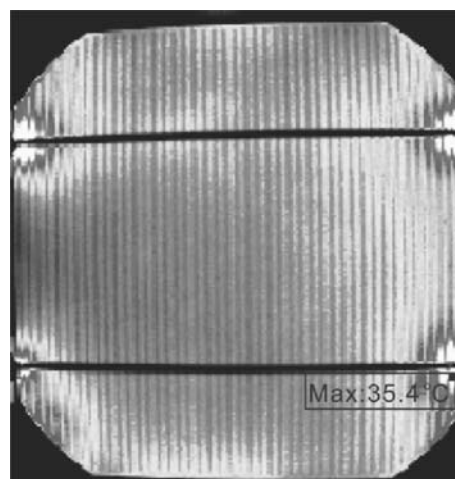
Fig. 4. Shunts caused by PECVD hooks under the four ends of bus bars.

PECVD chamber, where the wafer was supported by four hooks at the four edges. The SiN_x layer deposited on the places sheltered by the hooks is thinner than in other regions. The regions with thinner SiN_x layers were then covered with screen-printed Ag-paste contacts, where the contacts could easily penetrate through the emitter. Figure 4 illustrates this kind of shunt in the regions under the four ends of the bus bars. Better hook devices and tube PECVD could avoid this problem.

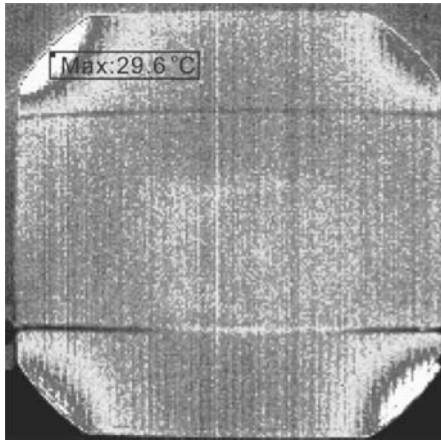
Fig. 5. Thermo-image of cell with shunts in the rear corners.

which would prevent the Al atoms from compensation diffusion into the back n^+ layer. The residue p-n junction could result in a bad shunt, and this could happen more easily in the rear corners, which is illustrated in Fig. 5. A better chamber structure and tube PECVD could solve this problem.

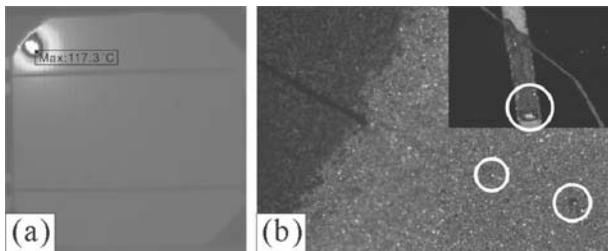
Fig. 6. Shunts caused by cracks: (a) Thermo-image of a shunted solar cell; (b) Optical micrographs of the shunted region.

A cracks in the started wafer or a crack due to inappropriate handling could give rise to leakage of the screen-printed paste through the crack to the opposite surface, resulting in a direct connection between the two sides. Figure 6(b) shows the Al paste running through the crack. It had a direct contact with the front silver finger. The leakage current was so large that the front silver finger was melted. As small printing pressure as possible and careful handling operation could decrease the crack shunts.

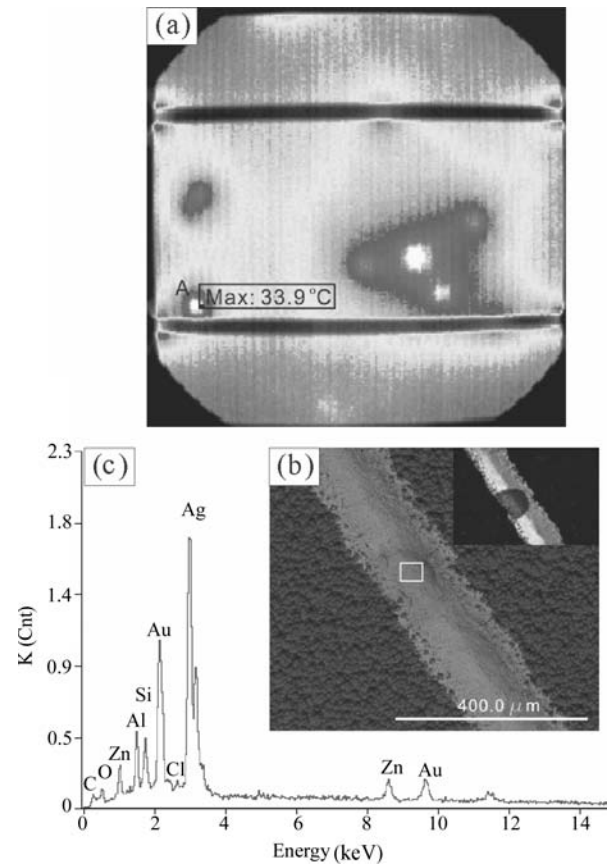
The front surface could be contaminated by Al-rich paste particles. The Al particles could penetrate through the SiN_x layer and compensate the n-type emitter, making the former emitter region become p-type during the sintering process. When the inverted p-type region was covered by the front contact, a bad shunted region could be present. Figure 7(a) shows the contaminated region by Aluminum marked with "A". Keeping the screen printing stage clean could decrease the contamination opportunity.

Fig. 7. Shunts caused by Al contamination on the front surface: (a) Thermo-image of the whole cell with A denoting the bad shunted region; (b) Back scattering electron image with the optical image in the corner; (c) Energy dispersive X-ray spectroscopy (EDS) of the box region showing the existence of aluminum.

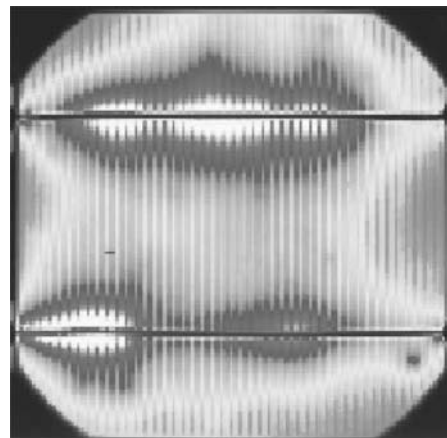
Fig. 8. Shunts caused by over sintering under the bus bars.

tacts during the sintering process if the sintering temperature is too high. Figure 8 shows the regions under the front contact bus bars with bad shunts. Getting stable and uniform temperature distribution in the firing furnace was vital for solar cell contact sintering.
